Case Study:

Multi-Phase PCB Remediation

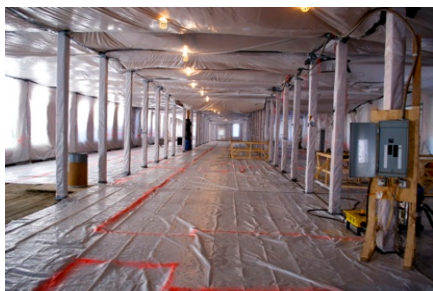
Phase I: Decking Removal

Triumvirate first created full containment in each of the four floors of the building with plastic sheeting, as well as installing negative air flow with a hepa-filter to force free-floating dust and contamination from the room. Next, Triumvirate's field service crew used dremels and ladders to remove several layers of PCB-impacted wood flooring across a 100,000 square foot area. This resulted in approximately 1250 cubic yards of impacted debris, which was then transported to a TSCA-permitted disposal facility. As an additional precaution, ceilings and walls were hand cleaned to remove residual paint.
